CASUALTY REPORT

DIVISION FOR INVESTIGATION
OF MARITIME ACCIDENTS

STEVNS POWER

Capsizing and foundering during anchor handling operation on 19 October 2003

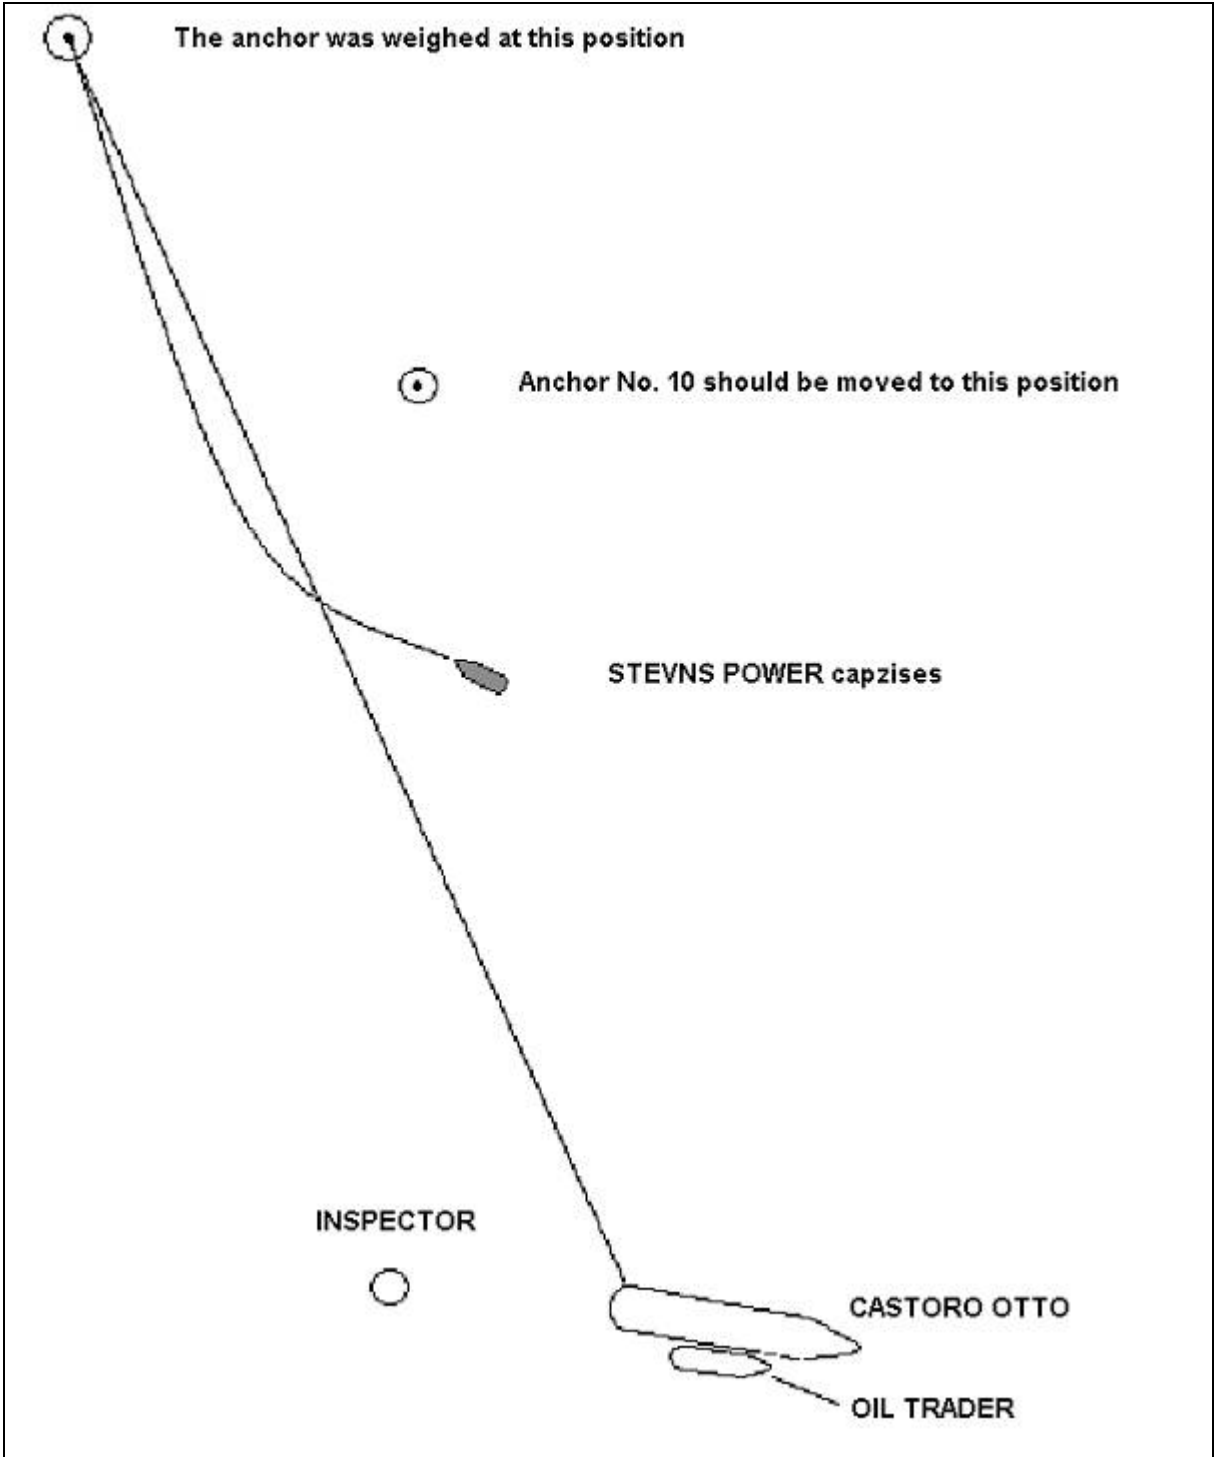
Suddenly at approx. 1715 hrs, the 3rd officer saw that STEVNS POWER began to heel over to port side and a bit to the astern. Thereby, STEVNS POWER got a more aft trim. He saw black smoke coming out of the funnel as if they were manoeuvring the engine.

STEVNS POWER's track during relocation of anchor no. 10.

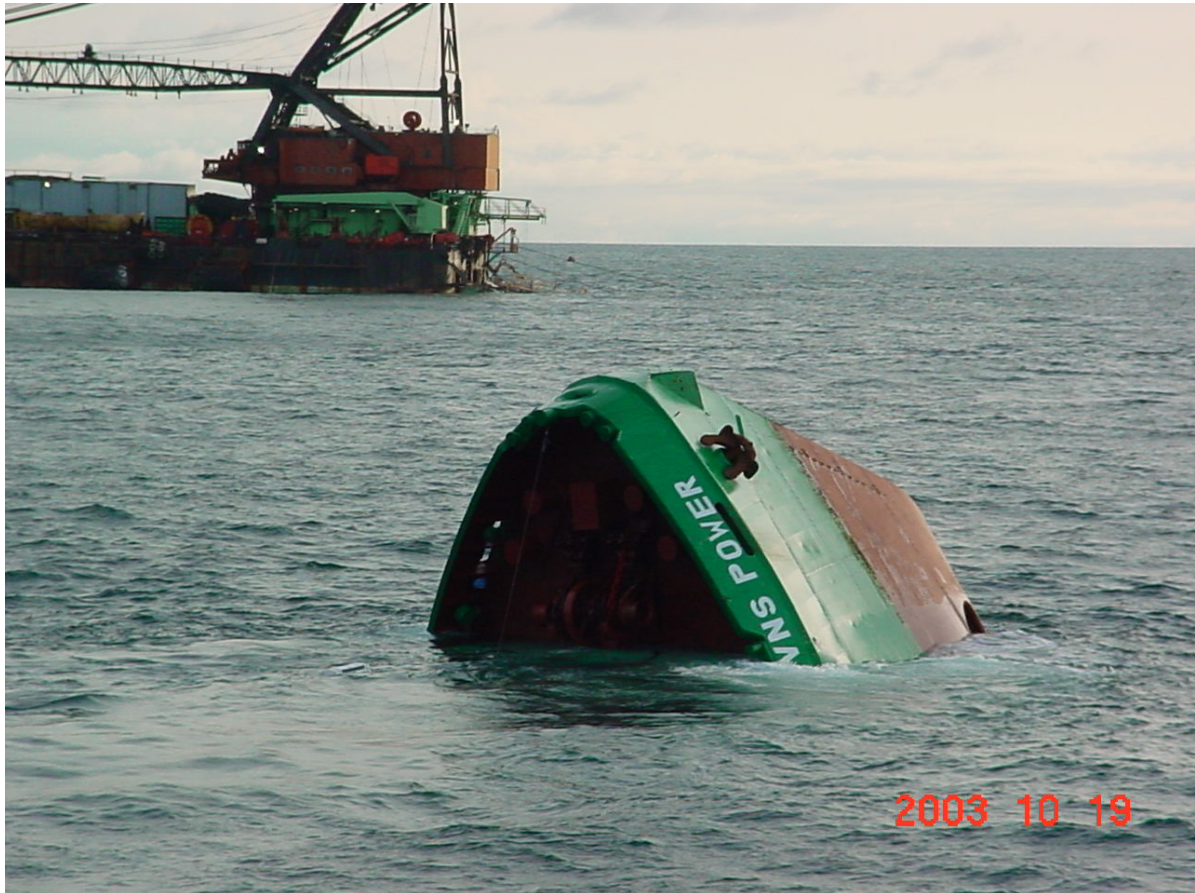
STEVNS POWER after capsizing.

STEVNS POWER capsized and sank when the vessel during a relocation of an anchor was manoeuvred astern while at the same time CASTORO OTTO pulled in on the anchor wire. The vessel was in a turn and the speed astern was relatively high, when the vessel heeled to port and water emerged on deck in port side. The speed astern resulted in the water flooded the deck and increased the heeling which very quickly caused the vessel to capsize. The water flooded the engine room, so that the vessel within less than one minute after the capsize only had the stem above the surface.

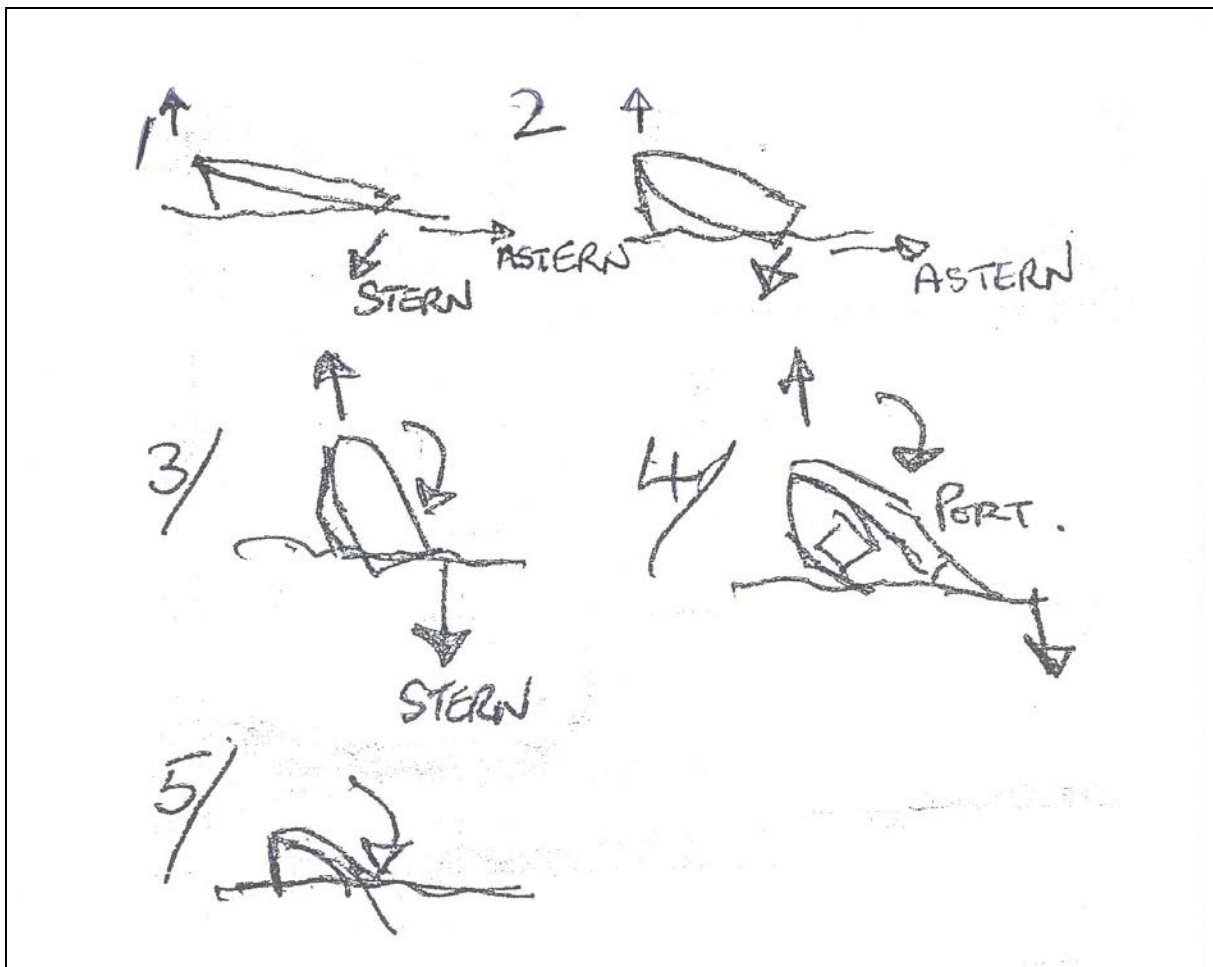
The person in charge of the ROV-operations on INSPECTOR watched STEVNS POWER shortly before the ship capsized and he could see that something was wrong. The stern of STEVNS POWER was lying very low. Smoke was coming out of the funnel as if they were giving full speed ahead. After this, STEVNS POWER capsized. It all happened in few seconds.

The officer in charge of the ROV-operation draw the situation as he saw it.

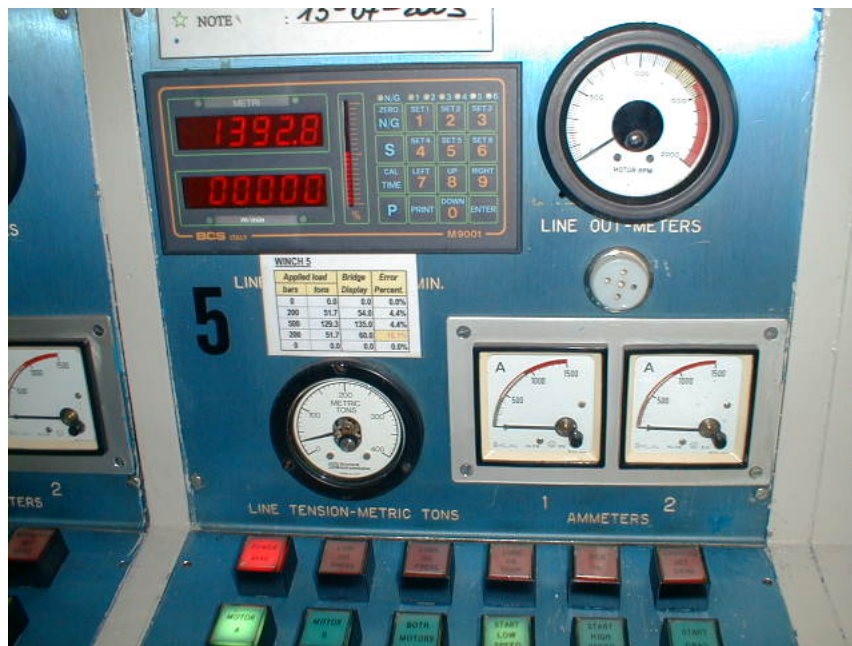
metric tonnes, if there is resistance on the anchor wire. The winch operator controls the recovering by using the speed regulation. If the tension exceeds approx. 30 metric tonnes, the winch stops the recovering and there is a risk that the anchor wire runs out uncontrolled. In that case the wire can be lost or damaged. The winch operator is therefore very careful not to exceed 20 metric tons on the tension meter.

Tension meter on the winch panel

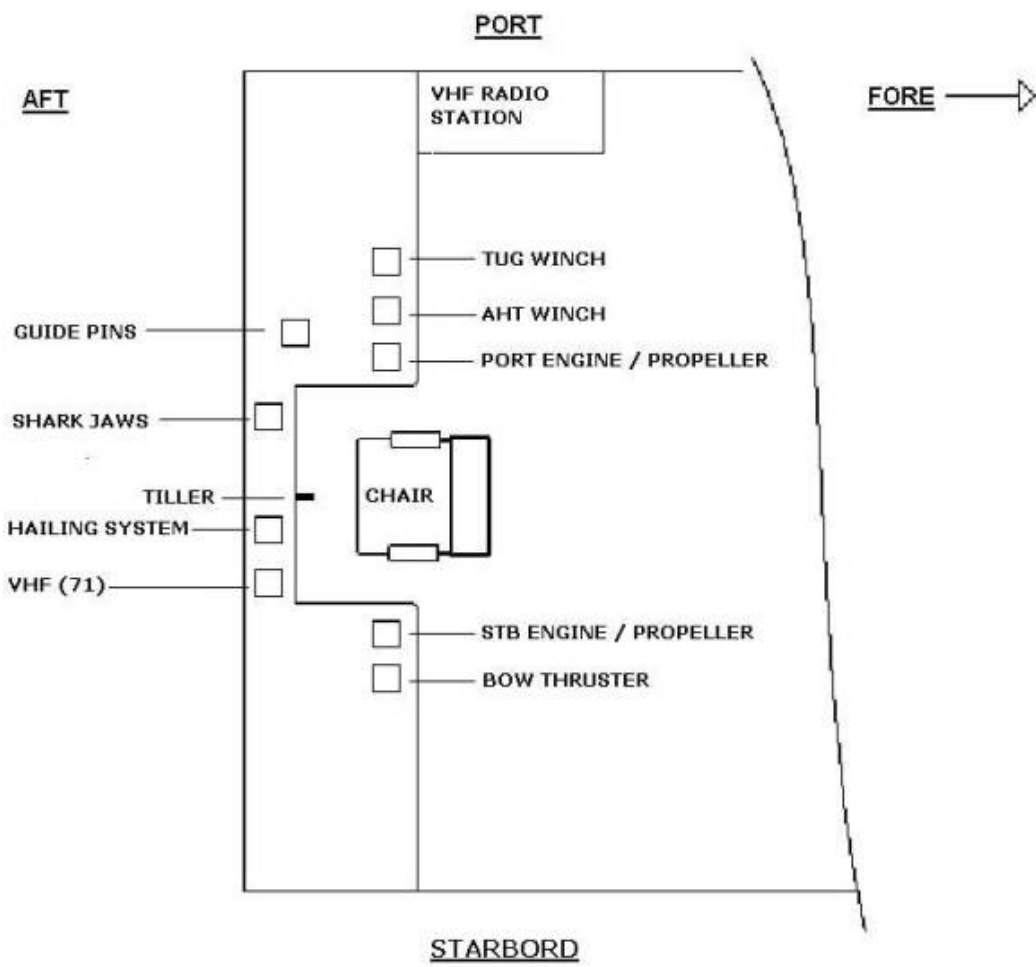
When STEVNS POWER was manoeuvred and pulled astern with high speed, the rudders sometimes did not stay in the amidships position but were pressed to starboard or port. In order to avoid this, the navigator had to use the tiller which was placed in a position where the navigator could operate it with the knees.

Aft part of the bridge on STEVNS POWER

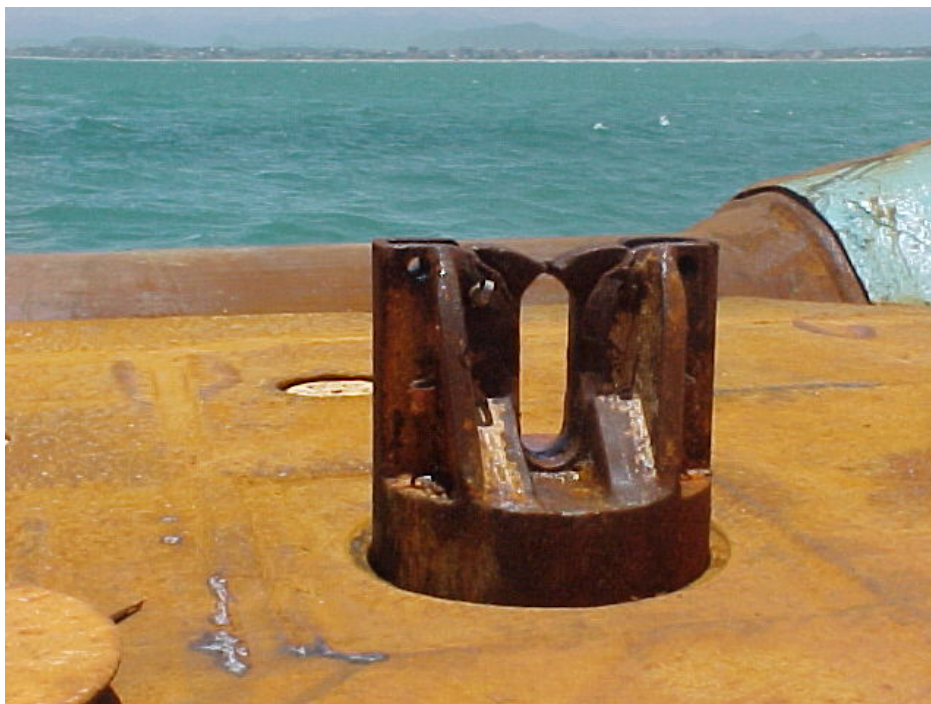
If the hydraulic failed on board STEVNS POWER, the shark jaws of the stopper was kept in a locked position.

Shark jaws – same type as on board STEVNS POWER.

If the stopper (shark jaws) had opened unintentionally, so the pennant wire could have got out and up on the cargo rail in the portside, it could have been a critical situation because of the athwartships pull in the wire. The Investigation Division finds it unlikely that the stopper opened. If the hydraulic pump had had a defect, the stopper would not have opened. Furthermore, the ROV videos show that there are no marks from a wire on the portside cargo rail, which had been painted in Las Palmas few months before.

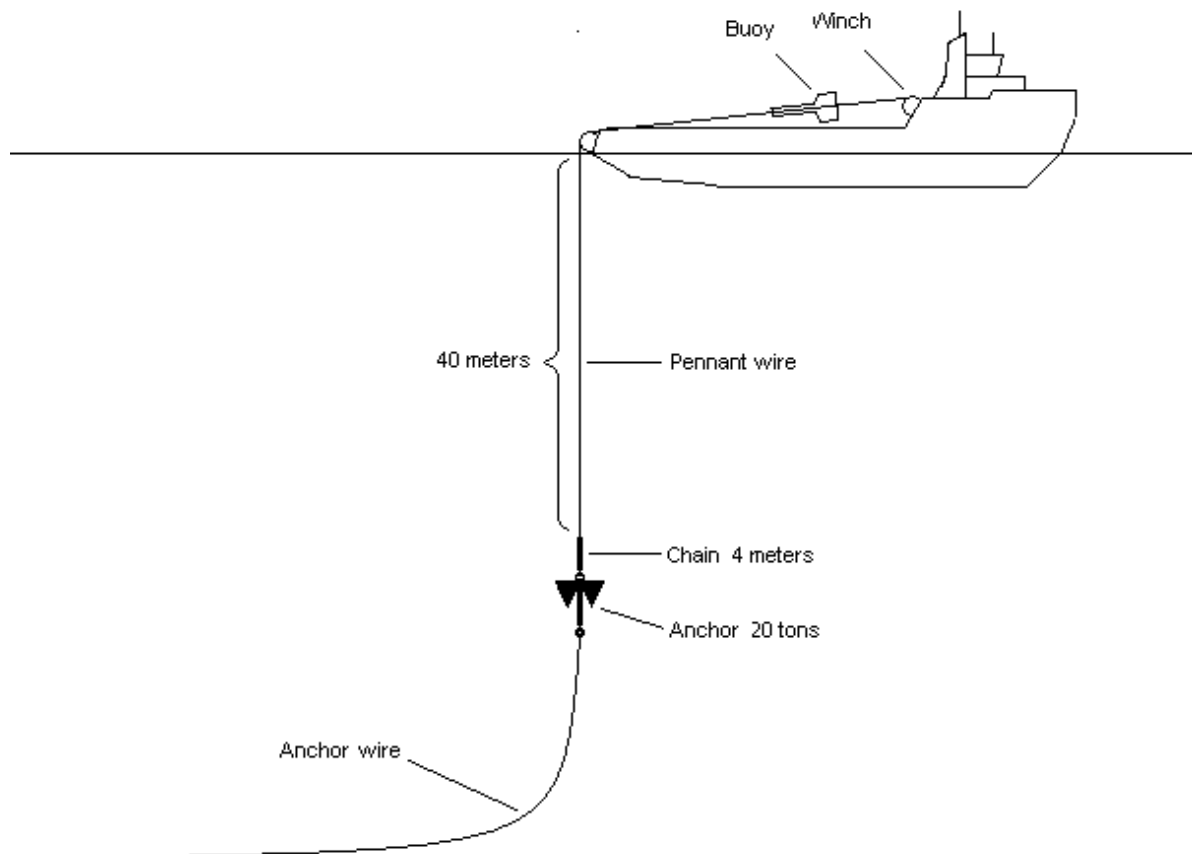
On a video taken by a ROV (Remote Operated Vehicle) it is possible to see the broken pennant wire. According to this, the pennant wire must have broken close to the stopper. This means that the anchor had hung 40 to 50 meters below STEVNS POWER during the anchor handling.

The anchor and pennant wire during anchor handling.

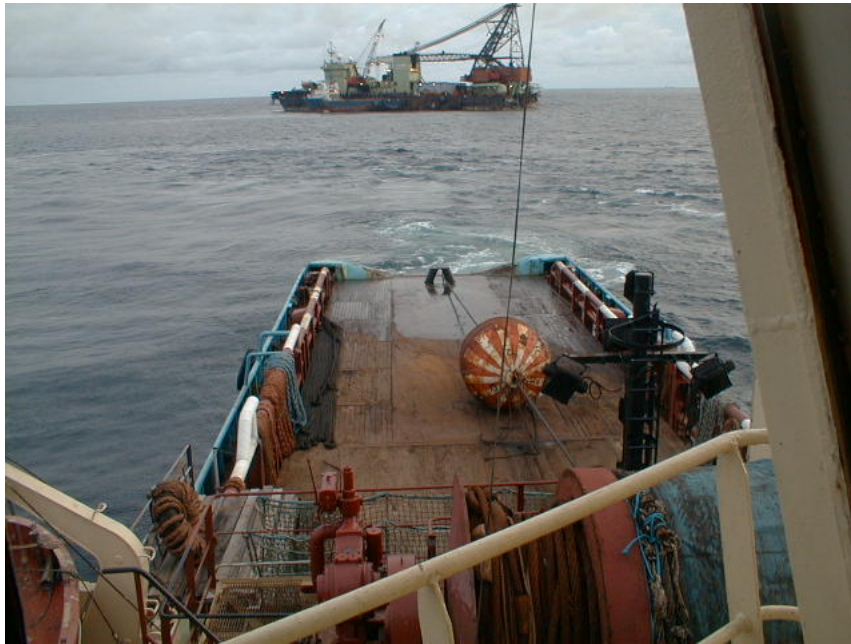
The pennant wire went through a pipe in the anchor handling buoy. When STEVNS POWER was capsized and floating with only the stem above the surface, the buoy came to the surface. At this moment the pennant no longer went through the buoy, meaning that the pennant wire had broken.

Photo showing pennant wire going through the buoy on aft deck.

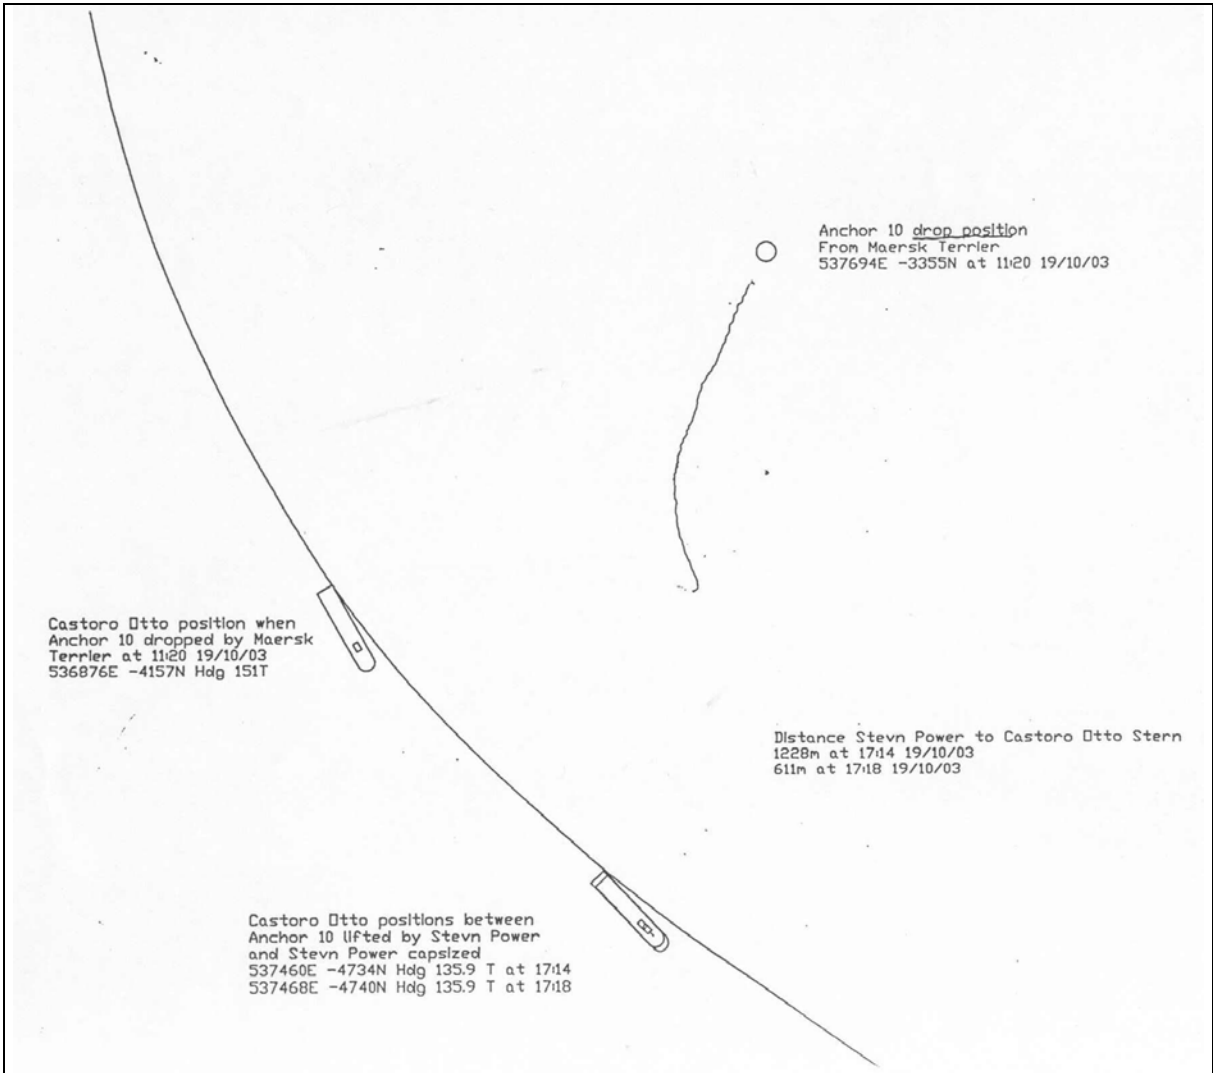
Prints of track from the sub sea surveyors of CASTORO OTTO.

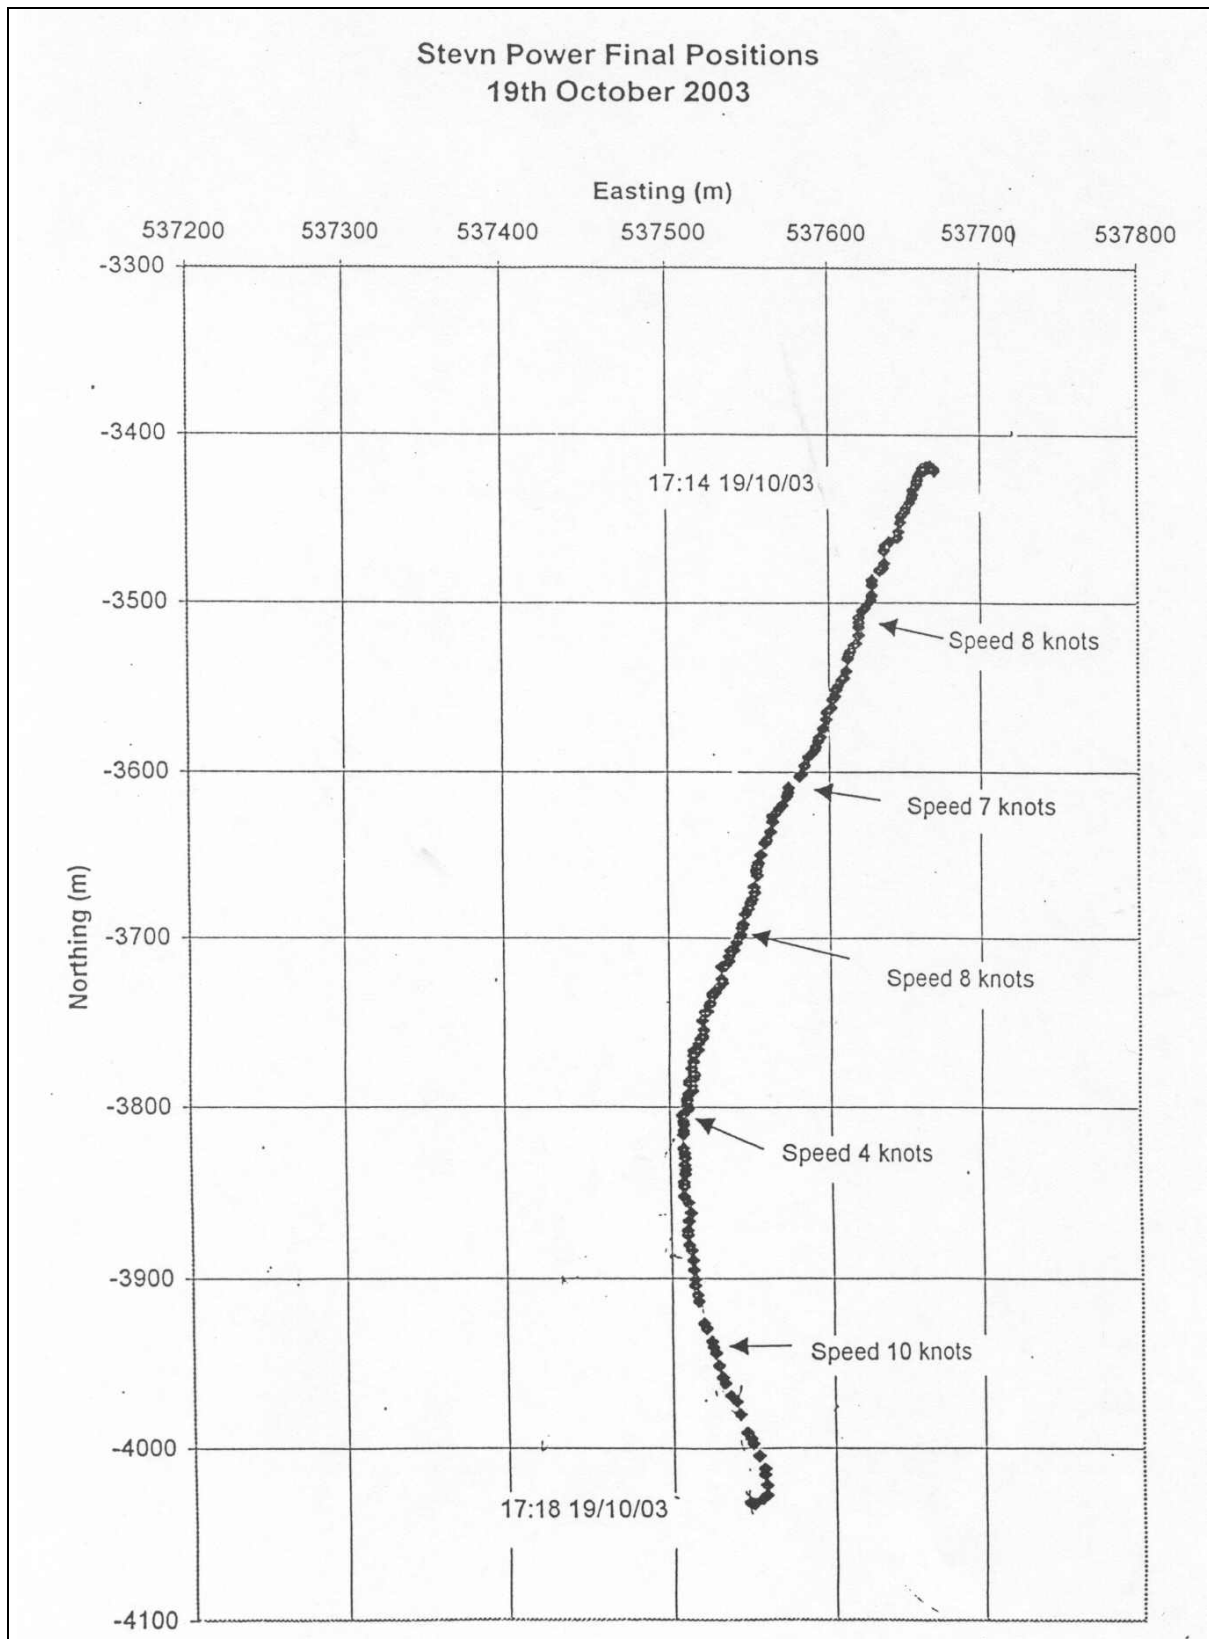
Print of track from the sub sea surveyors of CASTORO OTTO. The speed is written on the print by the surveyors and are according to them probably too high.

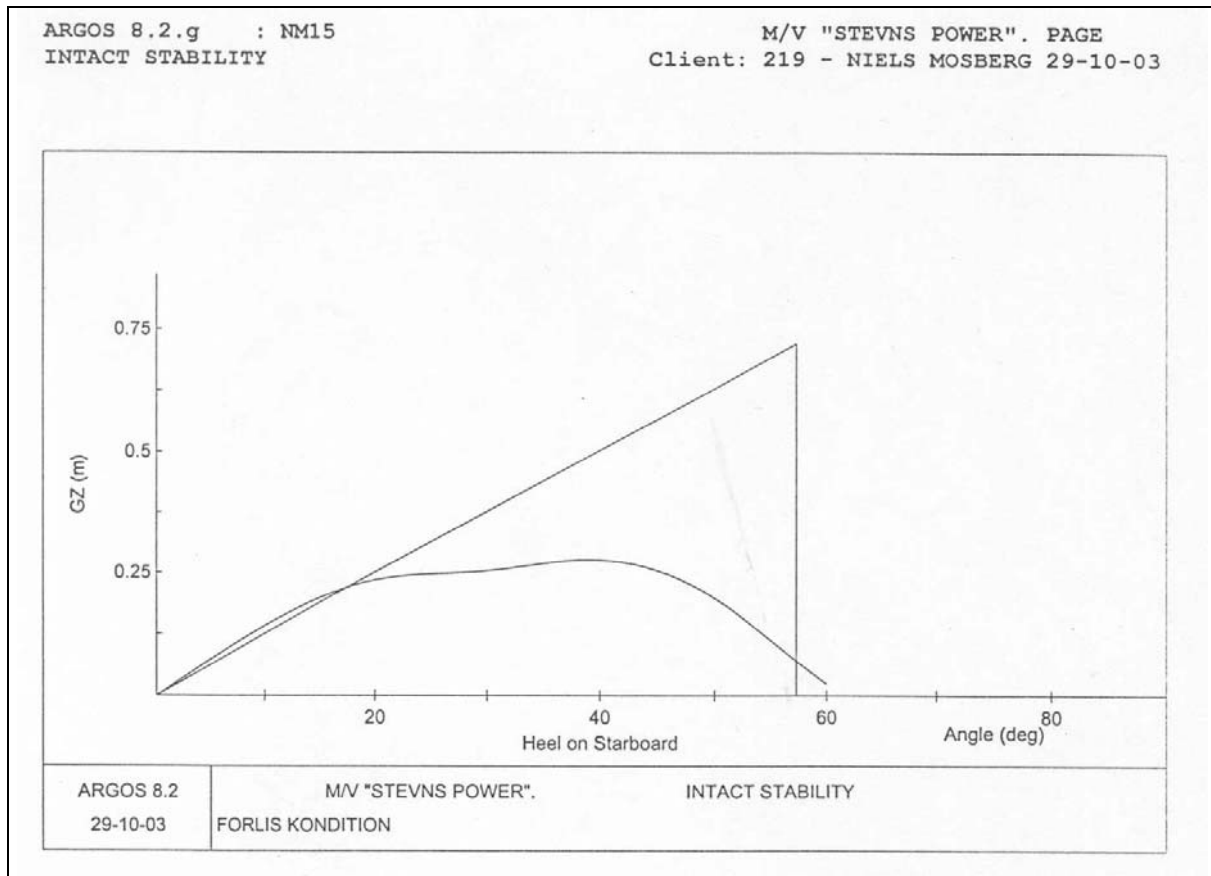
- The area under the GZ-curve between 30° and 40° was 0.047 radian metres – requirement 0.030 radian metres.
- The maximum righting moment GZ_{max} occurred at 39° - requirement minimum 25°.
- The righting moment GZ was 0.278 metres between 30° and 40° - requirement minimum 0.200 metres.
- The metacentric height GM was 0.721 metres – requirement 0.15 meters.

The GZ-curve of STEVNS POWER on the day of the accident.
